CATEGORY: ROLL SURFACE INDICATIONS

TYPE: LADDER TYPE FIRECRACKS

AFFECTS: WORK ROLL (HOT MILLS)

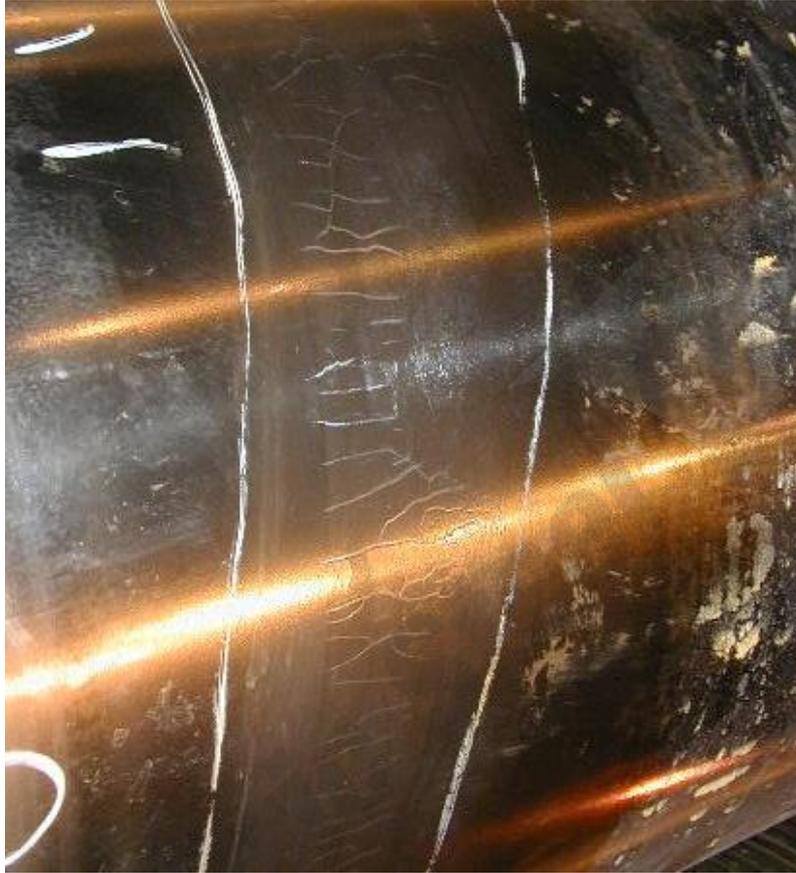
**Example 1**

Longitudinally aligned cracks contained in a circumferential band at the barrel surface of a work roll. The cracks are aligned like the rungs of a ladder.

The mechanism for the formation of ladder type firecracks is similar to what was described for fire crazing, but to a much more significant degree and in a different orientation (see section II.A – Fire Crazing). During mill operation, a localized lack of or an interruption in coolant at the barrel surface results in localized and circumferentially oriented heating of the roll surface. As a result of this circumferential heating event, the temperature of the roll surface within the affected area will attain a much higher temperature and to a greater depth of penetration than that of the surrounding material. The higher temperature within the affected area results in an excessive degree of localized expansion of the roll material. Due to the restriction of this expansion by the surrounding cooler roll material, a large degree of compressive stress will be generated within the affected area.

If the affected area is then exposed to water from the roll coolant system while still significantly hotter than the surrounding roll material, rapid cooling and contraction of the heated surface layer will occur resulting in the formation of fire cracks.

The severity of the cracks that form for a given roll material are dependant on the localized increase in temperature, the tempering temperature used during manufacturing, rate of cooling and depth of heat penetration (this being determined by how long the affected area was exposed to a lack of or an ineffective spray during rolling) and the rate of cooling there after. Extended exposure times without any coolant spray followed by rapid water cooling afterwards will result in a larger crack size that extends to a greater depth (radially).

Localized lack of roll coolant typically results from blocked coolant nozzles or an incorrect spray pattern. Typically ladder cracks will form with greater depth than that of stall band firecracks.

- If ladder cracks are observed then the spray header assembly should be inspected for correct alignment, pressure and volume. The sprays should be inspected to ensure that no blockages or heavy wear of the nozzle is present.
- It is strongly recommended that this type of cracking be entirely removed before further mill service. Due to the size, orientation and depth, ladder cracks are more affected by the shear and contact stresses generated during mill operation than fire crazing or stall band fire cracking. If not completely removed, ladder firecracks are therefore more likely to propagate at a rapid rate via fatigue deeper into the rolls cross section with continued mill service until eventual spalling occurs.

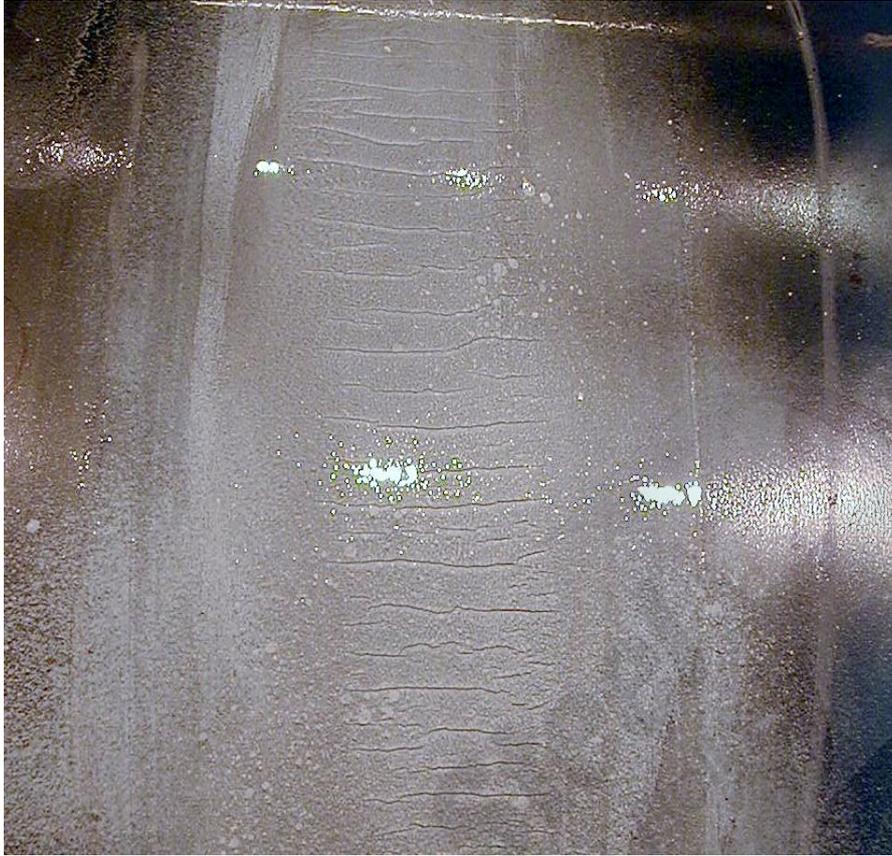
### **Example 2**

Longitudinally aligned ladder cracks at the surface of a high chrome iron work roll. Cracks in this instance are tightly closed and only become readily visible with the use of magnetic particle testing.
