CATEGORY: JOURNAL BREAKAGE
TYPE: BENDING FAILURE
AFFECTS: WORK ROLL AND BACK UP ROLL

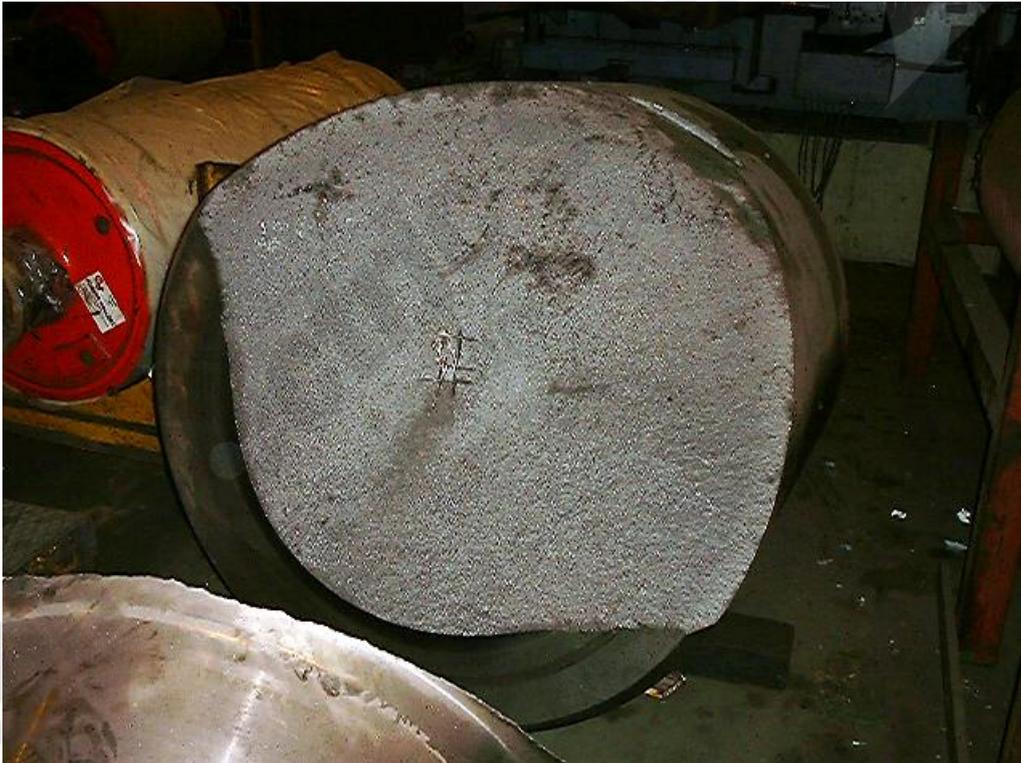
Example 1

Journal failure of a back up roll due to excessive bending stress. Failure initiated at the barrel to journal radius and then propagated instantaneously across the barrel diameter.

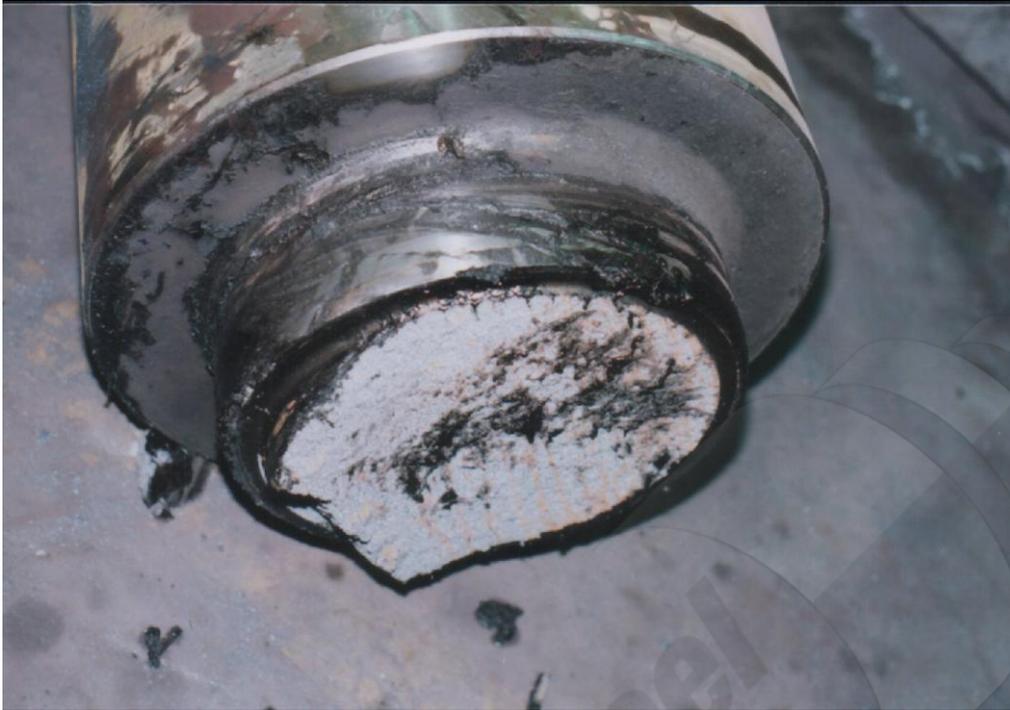
Figure 2
Failure of a work roll journal that occurred due to excessive bending load.
