CATEGORY: JOURNAL BREAKAGE  
TYPE: CORROSION CRACKING  
AFFECTS: WORK AND BACK UP ROLLS

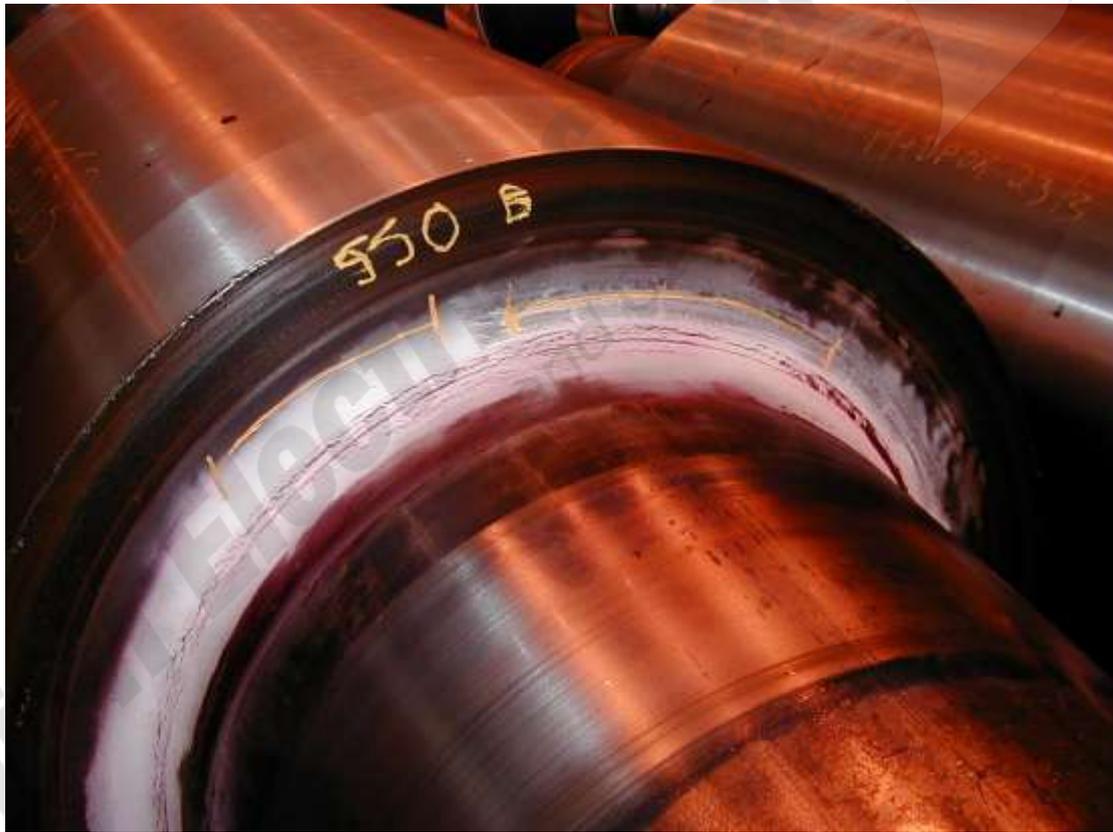
**Figure 1**

Cracking observed within the barrel end face radius of a back up roll after applying dye penetrant inspection.

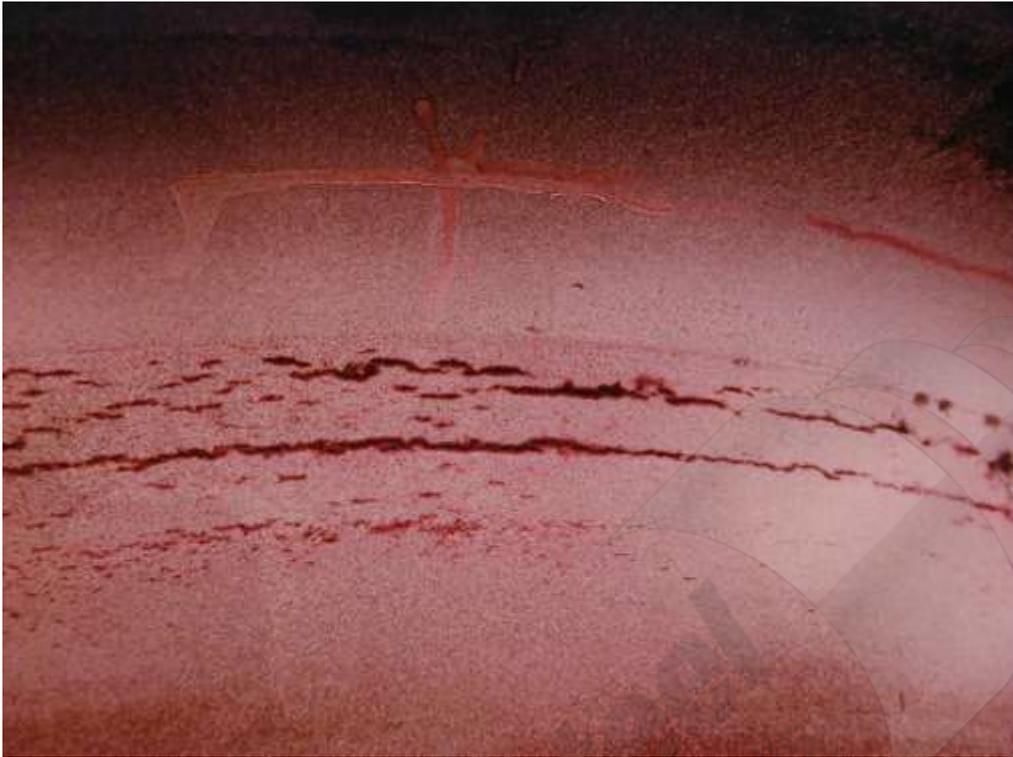
**Figure 2**

Close up view showing a series of small cracks that interconnect between individual corrosion pits and form larger circumferential cracks.

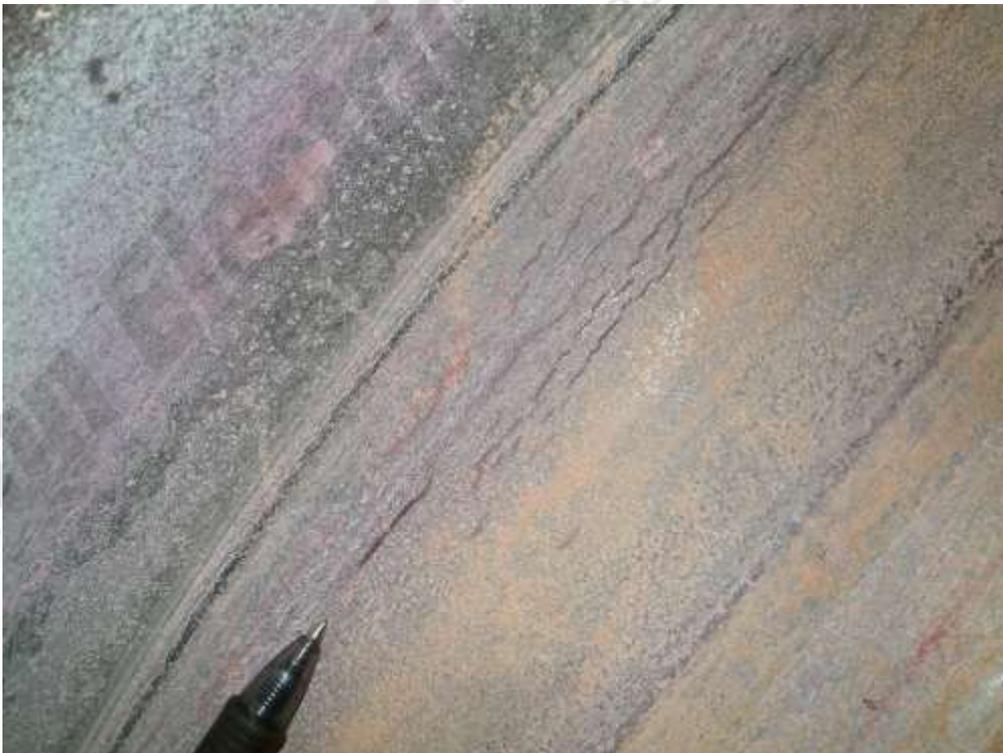
**Figure 3**

Corrosion pitting and cracking at the barrel end face radius of a back up roll

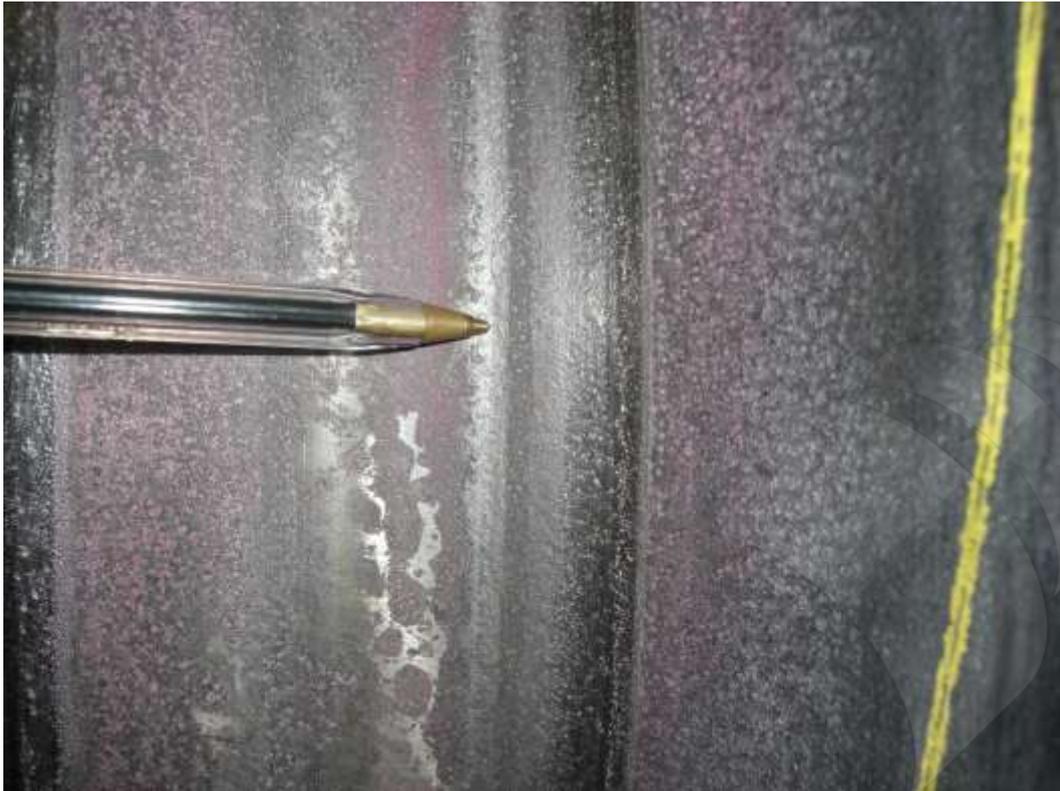
**Figure 4**  
Extensive corrosion pitting of a back up roll barrel face radius.

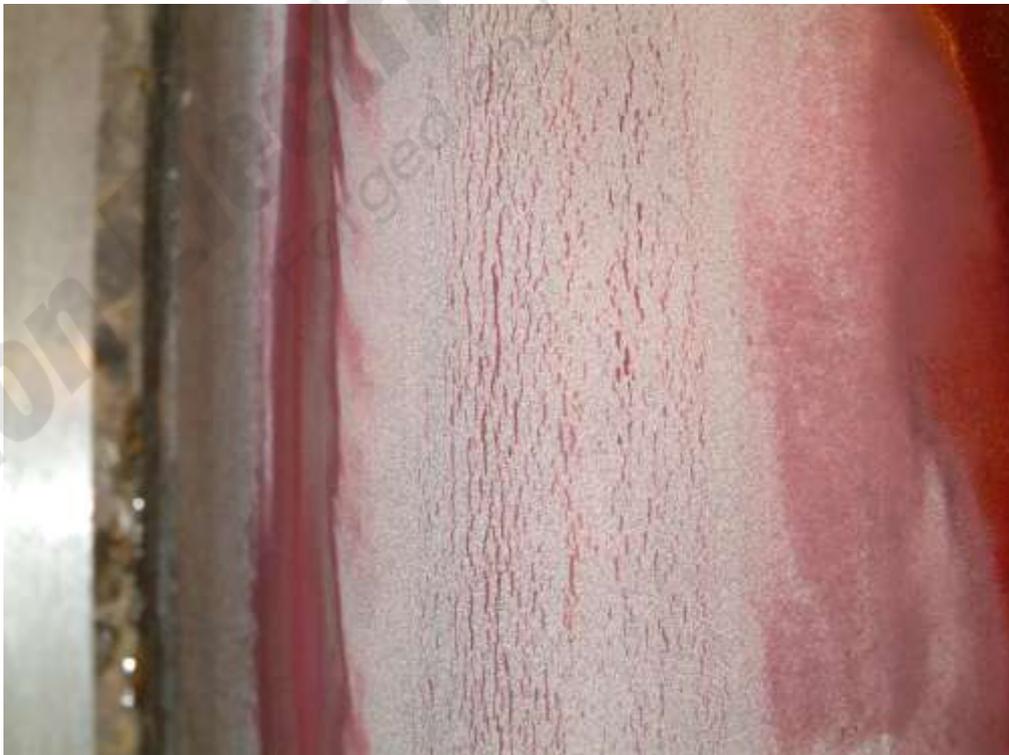
**Figure 5**  
Multiple small cracks at an early stage of formation within the corroded barrel face radius of a back up roll.

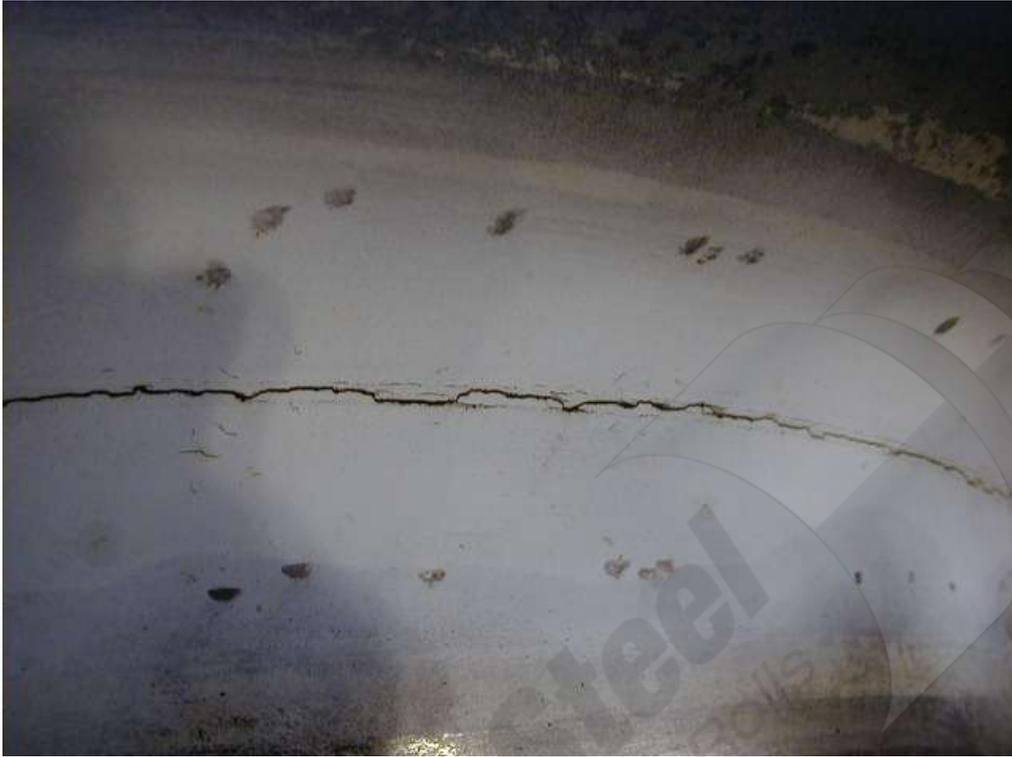
**Figure 6**

Cracking present at the barrel end face radius of a back up roll after applying magnetic particle inspection. Note the irregular nature of the crack as it is formed from many smaller interconnecting cracks.

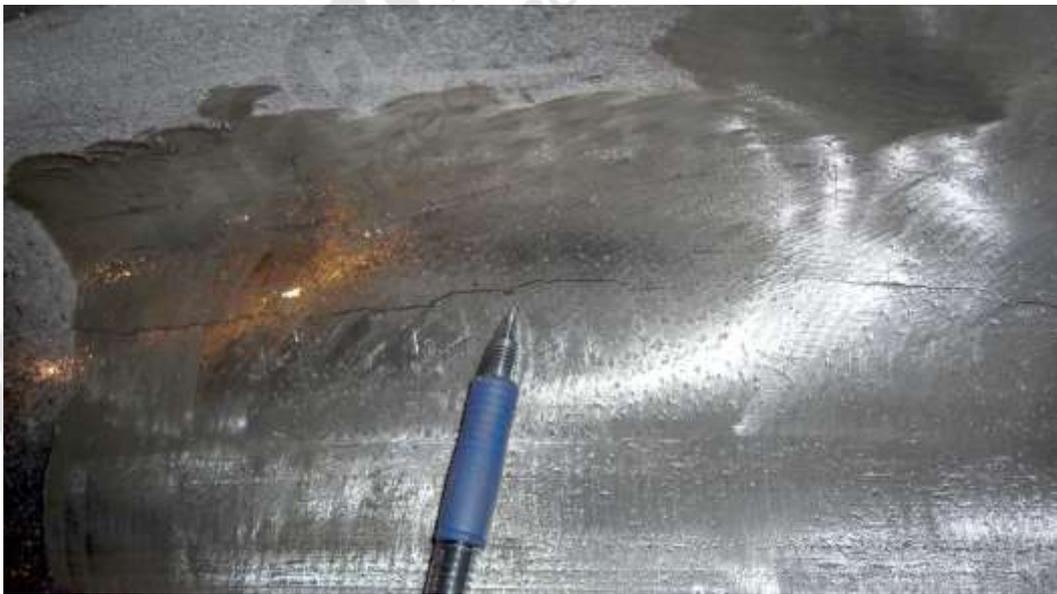
**Figure 7**

Cracking and corrosion pitting visible at the barrel face radius of a 2-high work roll. Surface has been lightly ground to remove oxidation.

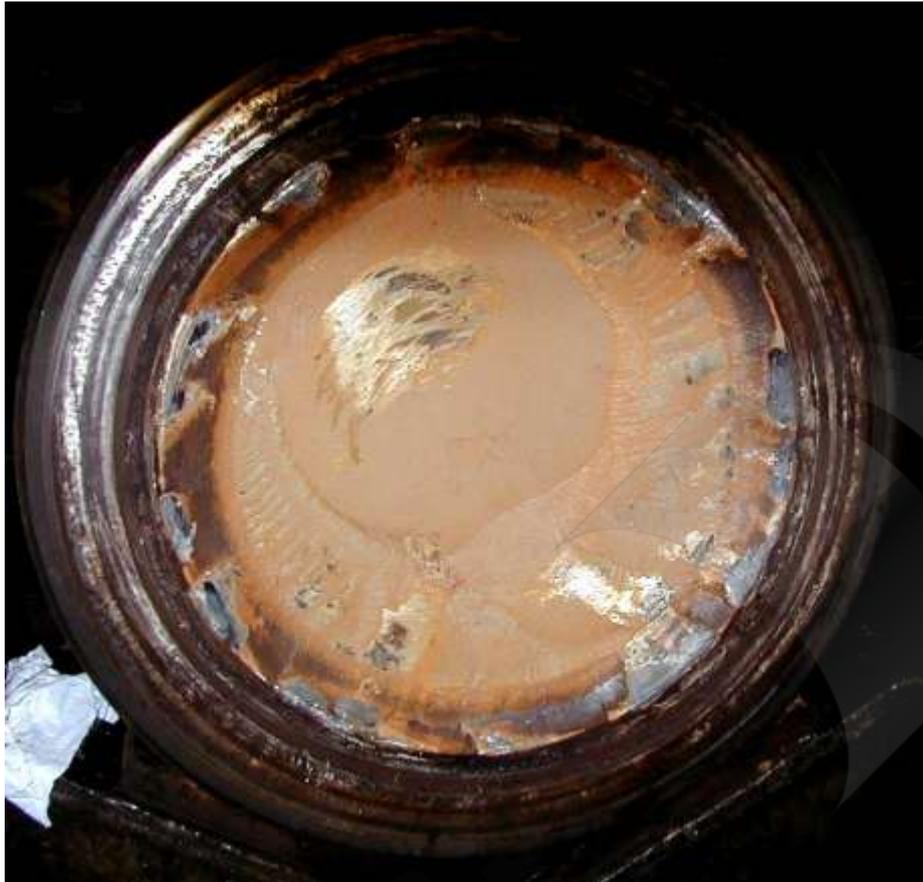
**Figure 8**

Cracks initiating at the barrel face radius propagated inward and ultimately resulted in a journal fracture.

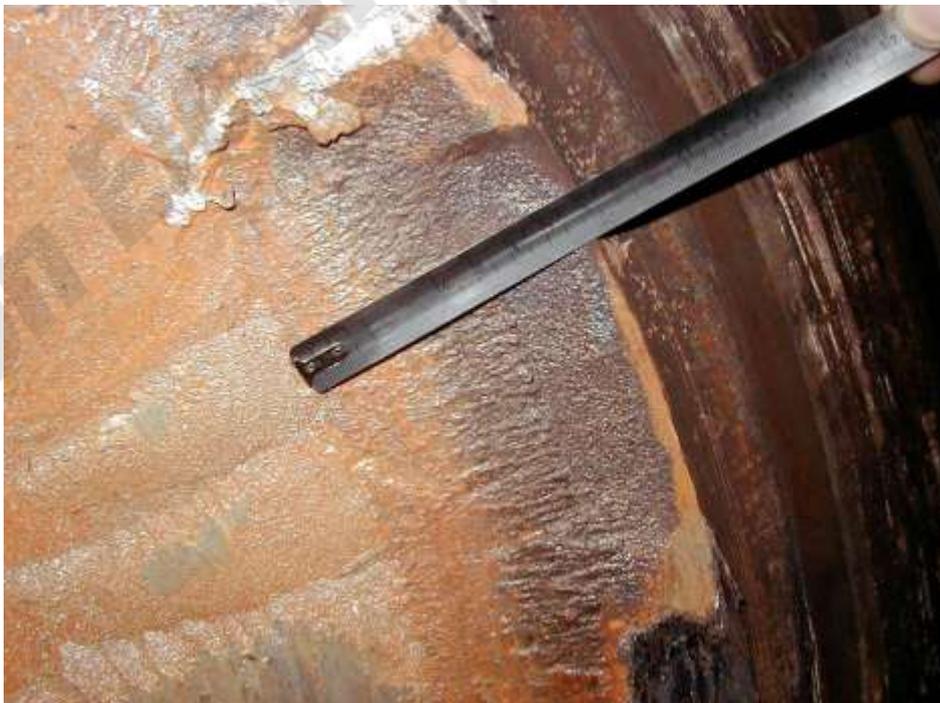
**Figure 9**

Area of cracking/fatiguing (blackened) can be seen on the outside edge of the fracture surface.
