CATEGORY: ROLL SURFACE INDICATIONS

TYPE: LADDER TYPE FIRECRACKS

AFFECTS: WORK ROLL (HOT MILLS)

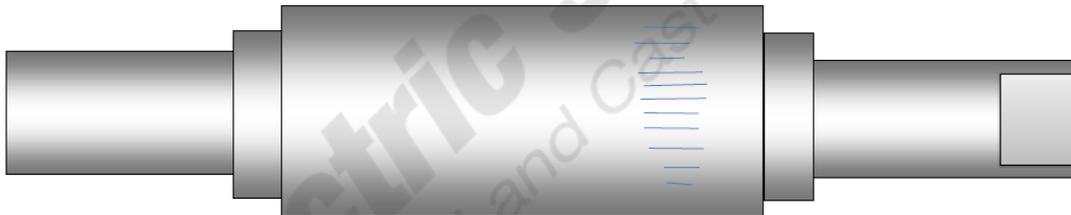
Ladder cracking is characterized as a series of longitudinally aligned heavy cracks contained in a circumferential band typically present around the full barrel diameter. Ladder firecracks are mostly oriented in the longitudinal direction, however some degree of circumferential cracking may also be present connecting between adjacent longitudinal cracks. The cracks will be significantly larger and deeper (radially) than the normal fire crazing (section II.A) that will also be present. If the cracks are large and open enough, they can generate repetitive surface indications on the rolled product that correspond to the effected area of the roll surface.

- If ladder cracks are observed then the spray header assembly should be inspected for correct alignment, pressure and volume. The sprays should be inspected to ensure that no blockages or heavy wear of the nozzle is present.
- It is strongly recommended that this type of cracking be entirely removed before further mill service. Due to the size, orientation and depth, ladder cracks are more affected by the shear and contact stresses generated during mill operation than fire crazing or stall band fire cracking. If not completely removed, ladder firecracks are therefore more likely to propagate at a rapid rate via fatigue deeper into the rolls cross section with continued mill service until eventual spalling occurs.
